California Division of Mines and Geology

Fault Evaluation Report FER - 194
Peralta Hills Fault
Orange County

Christopher J. Wills
Associate Geologist
May 4, 1988

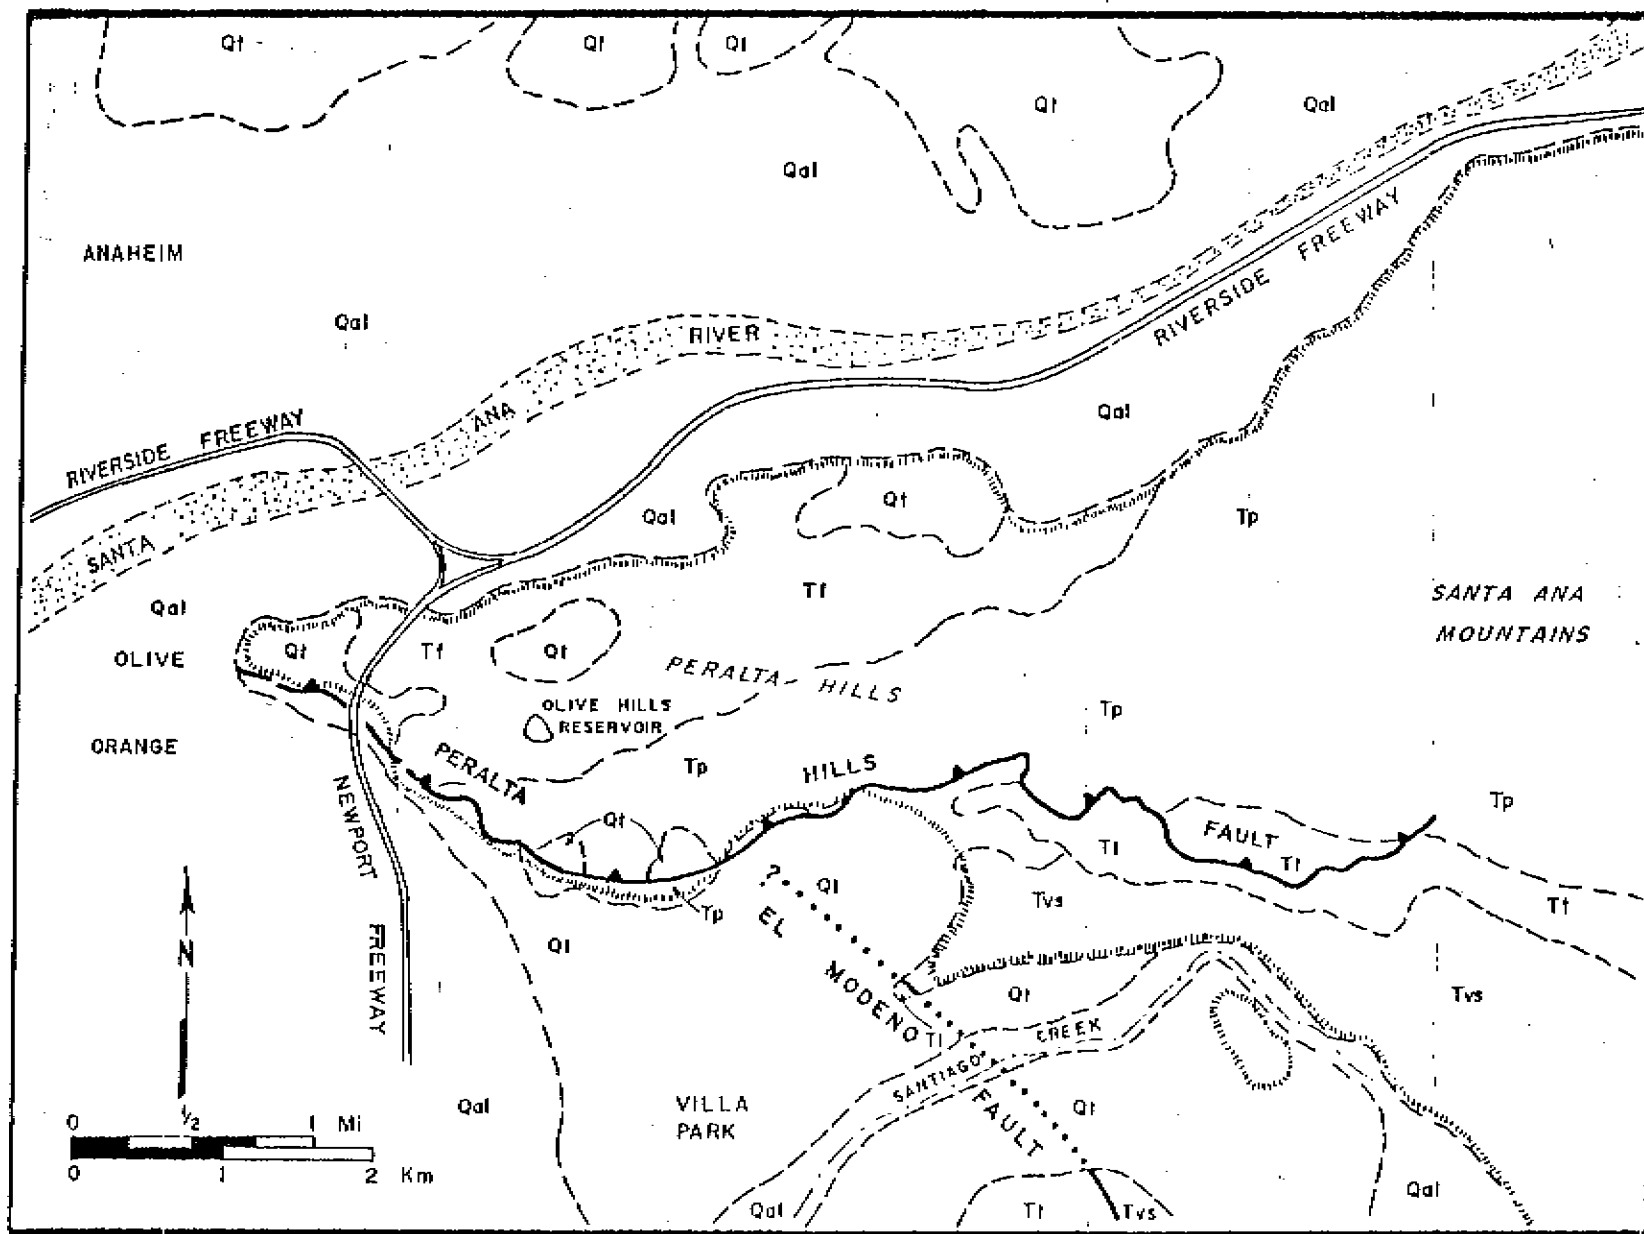
Bryant and Fife (1982) present a different interpretation of the faulting in the Peralta Hills (Figure 2). They suggest that the fault along the south side is a thrust fault, not the El Modeno fault, and is continuous with the thrust fault above Cerro Villa Heights mapped by Schoellhamer and others (1981) and Morton and Miller (1981). Bryant and Fife also extend this fault 2 miles to the east of the end of the fault mapped by Schoellhamer and others and Morton and Miller. Bryant and Fife name this fault the Peralta Hills fault.

Figure 2. Generalized geologic map of Peralta Hills modified from Morton and Miller (1981). Qal = alluvium, Qi = terrace deposits, Tl = Fernando Formation, Tp = Pueblo Formation, Tl = Topanga Formation, Tvs = Vaqueros-Sespe Formation,

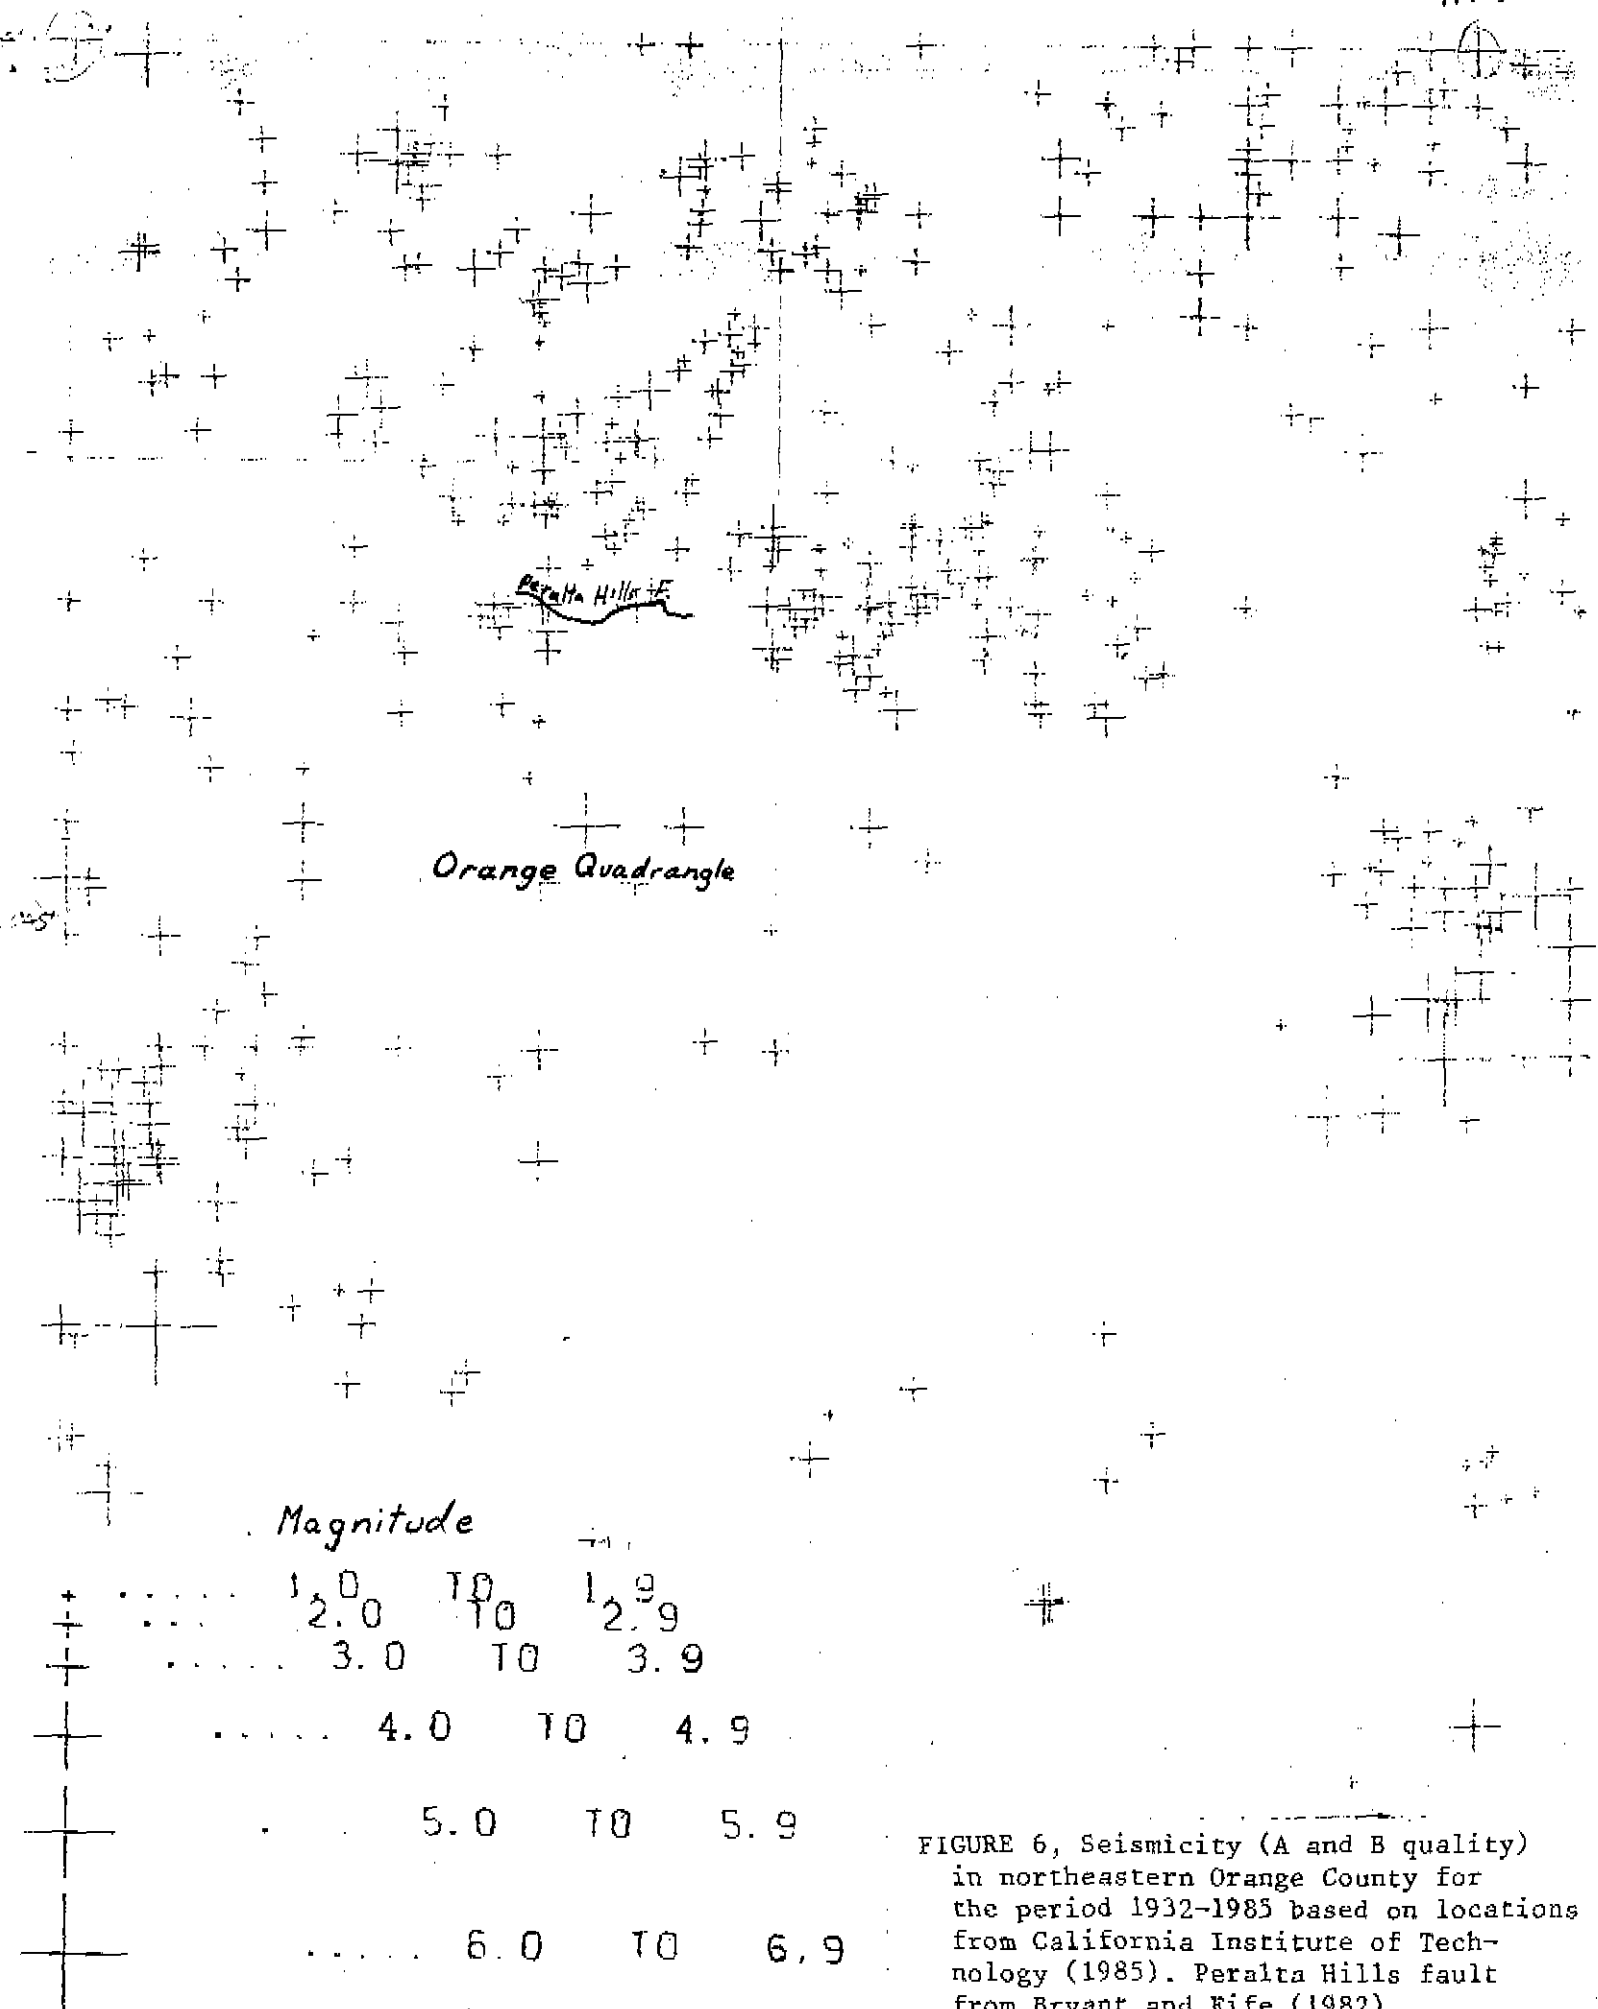
Seismicity of the northeastern Orange County area is shown on Figure 6. A and B quality epicenters are for the period 1932 to 1985. The northeastern third of the Orange Quadrangle is seismically active but seismicity is not clearly confined to discrete zones. Although microseismicity along and north of the Peralta Hills fault could be due to movement on the fault, such movement is not required by the seismicity.

FIGURE 6, Seismicity (A and B quality) in northeastern Orange County for the period 1932-1985 based on locations from California Institute of Technology (1985). Peralta Hills fault from Bryant and Fife (1982).

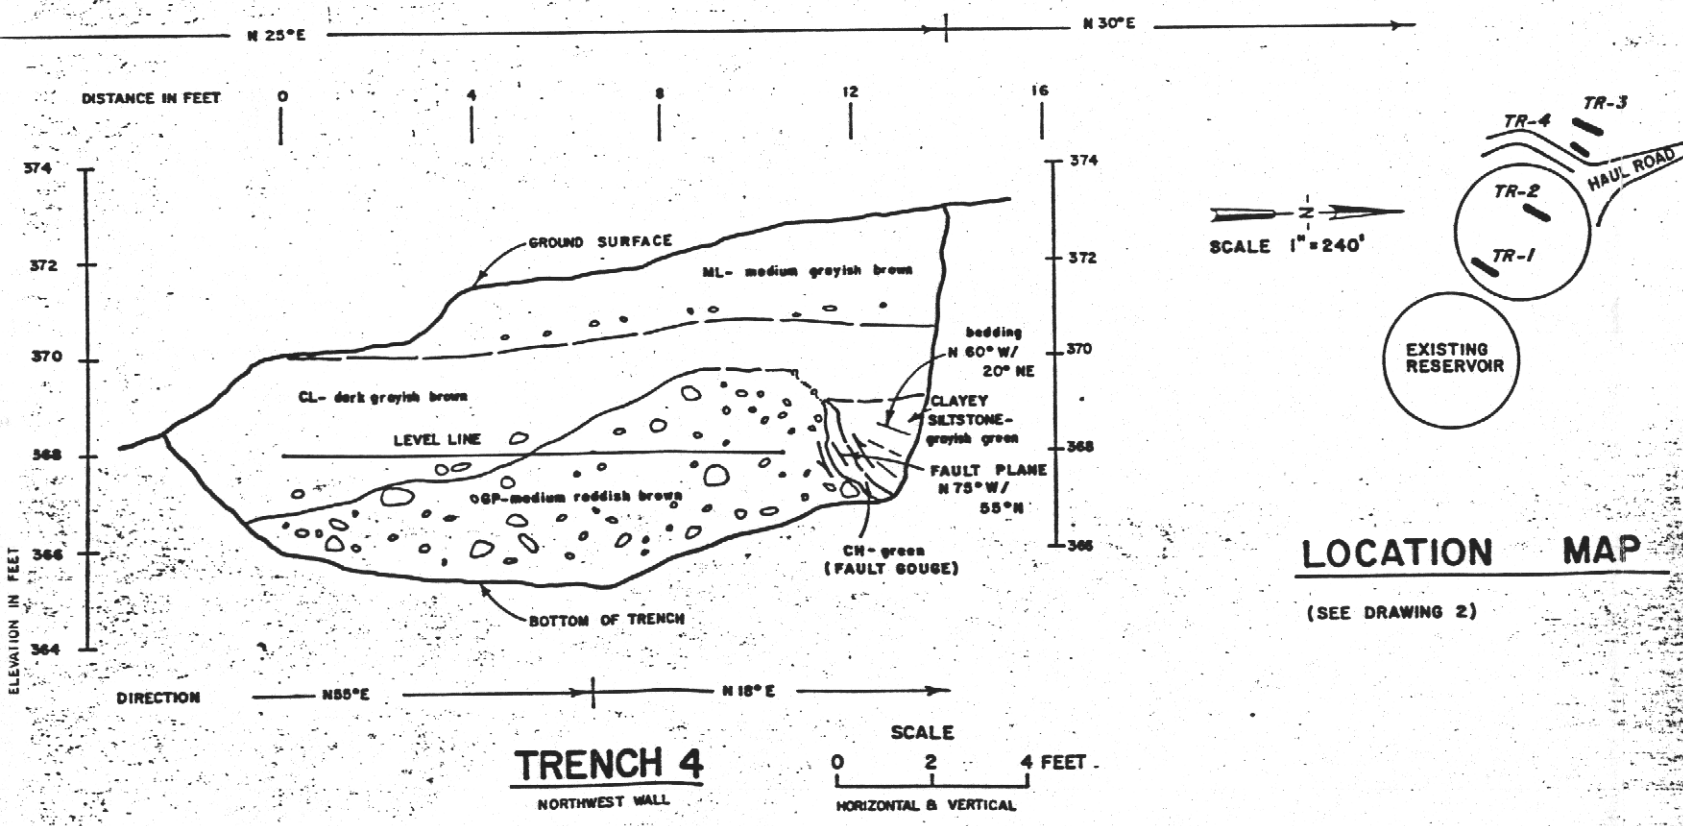
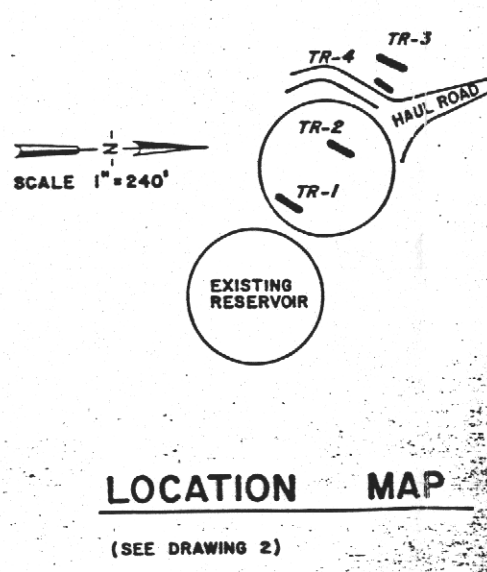
Immediately east of this site Converse Ward Davis Dixon (1979a) investigated a proposed water tank site (Segment 1 on Figure 3). Here, trenching showed Puente Formation siltstone reverse-faulted over terrace deposits (Figure 4). In trenches 3 and 4 (locality 1, Figure 3) the fault is shown to dip 55° N to 57° N. with Puente Formation siltstone displaced over gravel (Qoa2 of Schoellhamer and others, 1981). The fault is projected upward as a thrust through two soil units, apparently based on a soil color change in trench 3 and the apparent truncation of a lower soil. Trench 4 also shows a soil step, but the fault is not projected to the surface (Figure 4). Converse Ward Davis Dixon did not identify any shears in the soil but concluded that the fault had offset the soil. Roy Shlemon also observed the trench exposures in 1979 and concluded that the faulting was Holocene based on subtle geomorphic features and offset soils of mid-Holocene age (personal communication, 1987). Although the log of trench 3 does show apparent offset of soils, the sense of offset is down to the north, which is inconsistent with thrusting. This suggests that differential soil development or soil creep could be the cause of the apparent soil offset.

Holocene movement of the Peralta Hills fault has been proposed at two locations. On segment 1 Converse Ward Davis Dixon (1979a) propose thrust faulting of Holocene soils. Their trench logs, however, show a soil step which could be interpreted as differential soil development, colluvium deposition on irregular topography, extension at the head of a landslide or down to the north normal faulting. Holocene thrust faulting is not consistent with the features logged in the trenches (Figure 4). On segment 4 Converse Ward Davis Dixon (1979b) proposed that Puente Formation has been thrust 50 feet over Quaternary slopewash. Their trench logs, however, show landslide debris over slopewash (Figure 5). It is impossible to determine from these trench logs or from exposures observed in 1988 how much, if any,

FIGURE 4. Trench logs by Converse Ward Davis Dixon (1979a) at locality 1, Figure 3. Note change in soil color above fault in trench 3 and relative elevations of bedrock and terrace deposits in both trenches.
